WHARF CONTAINER CRANE

CASE STUDY

ENVIROPEEL
THERMOPLASTIC SYSTEMS

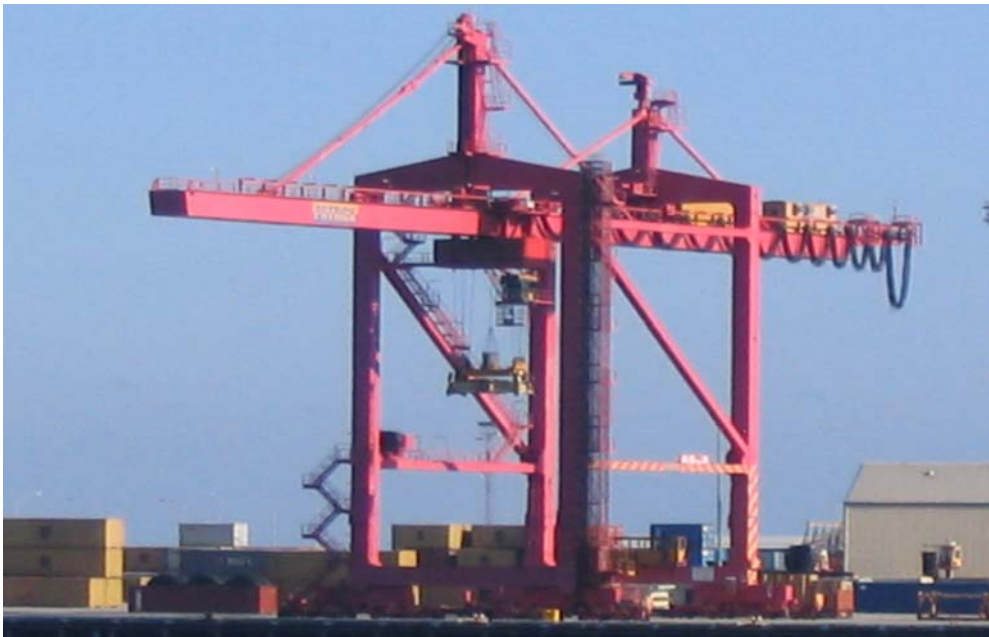
*Above: A view of the Fremantle Port Portainer Crane
Left: A length of track showing the corroded cleats and pigtails*

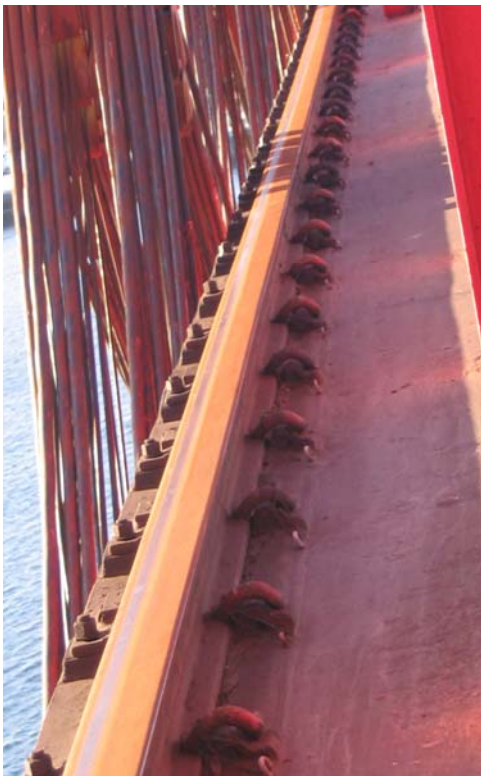
The cleats and pigtails on the crane platform suffered severe corrosion caused by the marine environment and being exposed to the harsh wind and weather conditions that may vary from low temperatures and downpours during winter while the summer temperatures can reach a scorching 40+°C. They were prone to breaking free and creating falling debris and a hazard to personnel working below.

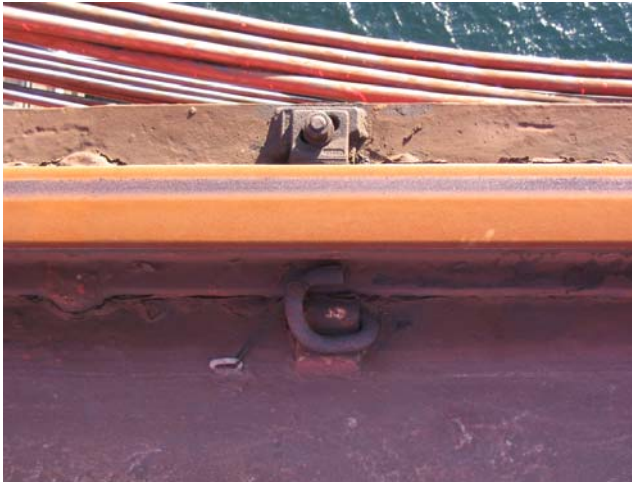
Top: A single cleat and pigtail prior to coating
 Above: Cleat and pigtail after being coated with Enviropeel
 Right: A length of track on the jib showing coated cleats linked with Enviropeel to improve security
 Below Right: Views of Enviropeel coated cleats
