Within 6 months of its construction, bearing bolts on a bridge in the New Territories of Hong Kong were showing signs of corrosion. The original cast steel and galvanized bolted sections were failing, partly because of damage to the bolts during installation, and replacement stainless steel bolted areas were suffering from galvanic corrosion problems.

BRIDGE BEARING BOLTS HONG KONG **ENVIROPEEL** THERMOPLASTIC SYSTEMS CASE STUDY

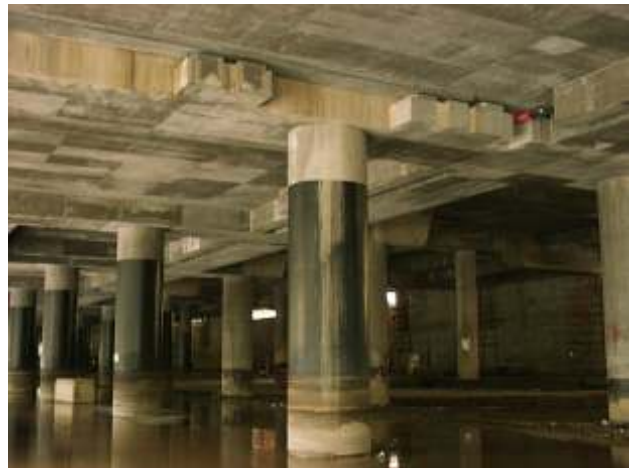
Pictured above left: Streaming corrosion from rusting bolts after only six months.

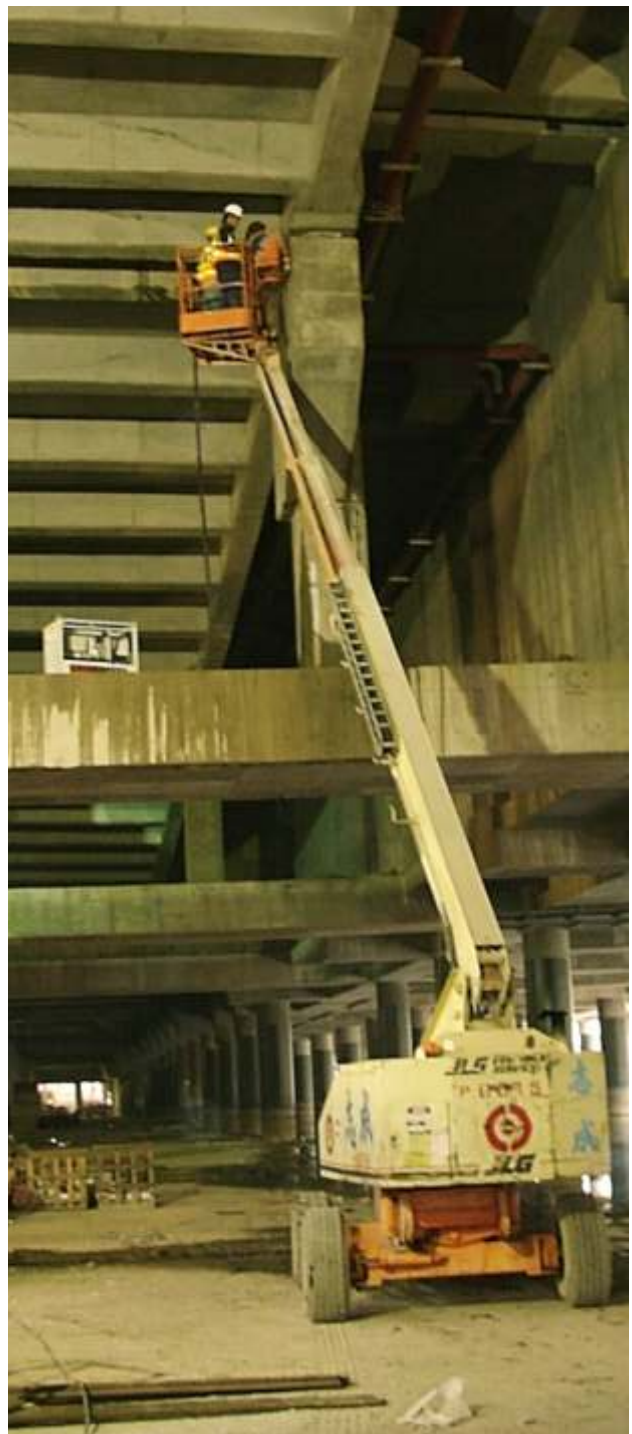
Above right: Extreme access problems meant that precasting bolt caps on site from Enviropeel and then fixing them in place with molten material was often the most appropriate technique.

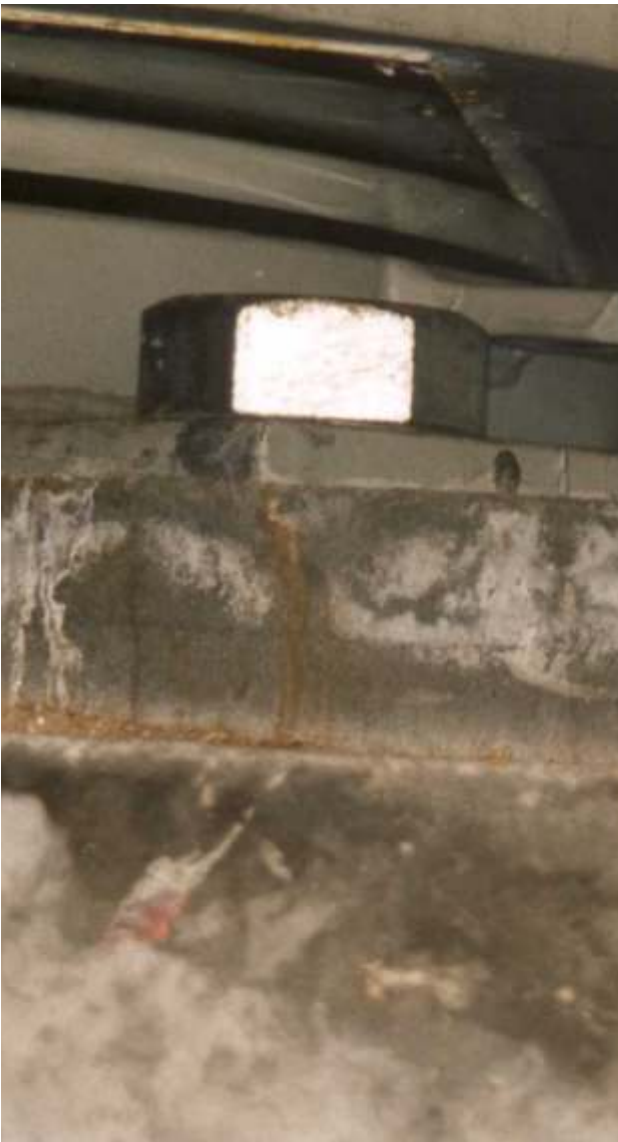
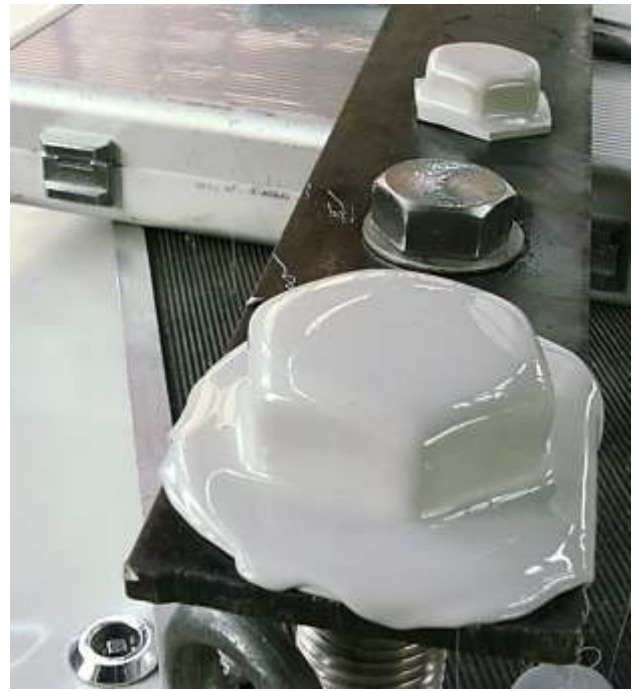
Below: This typically restricted area shows how the Enviropeel material was applied.

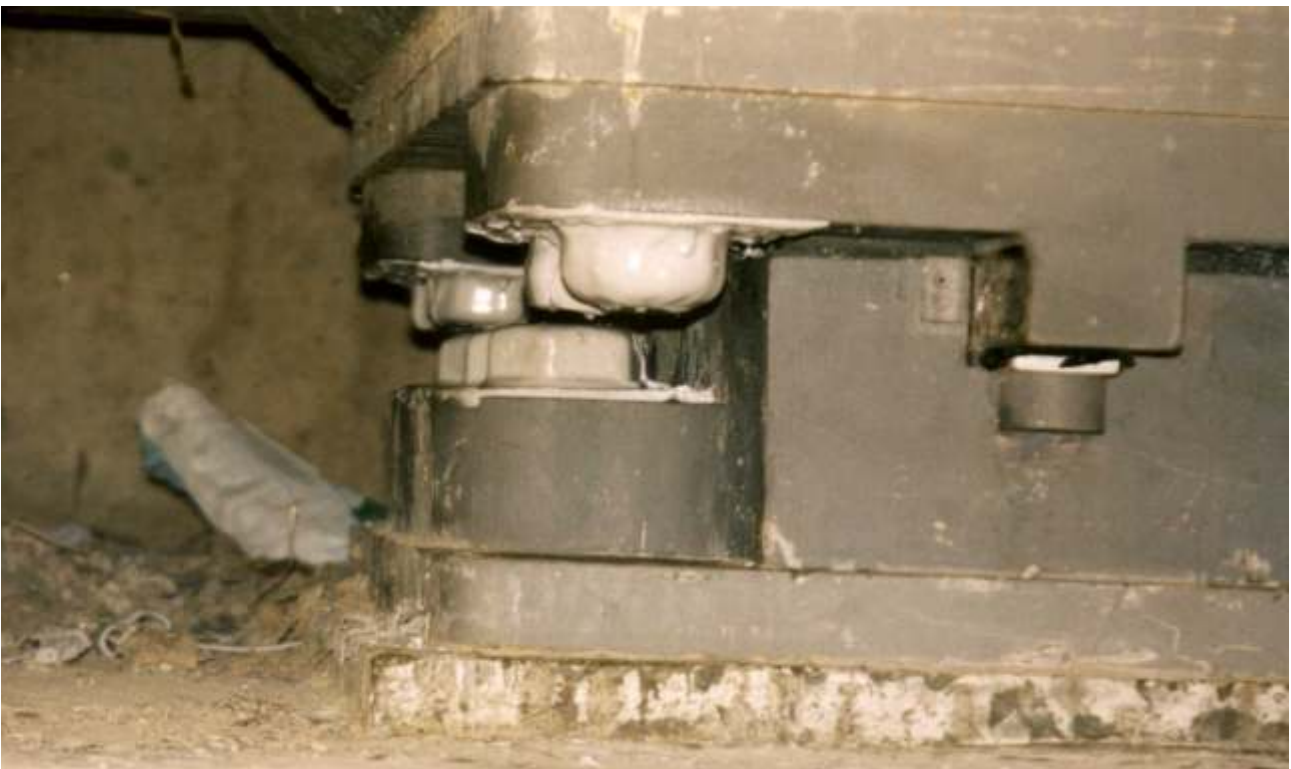
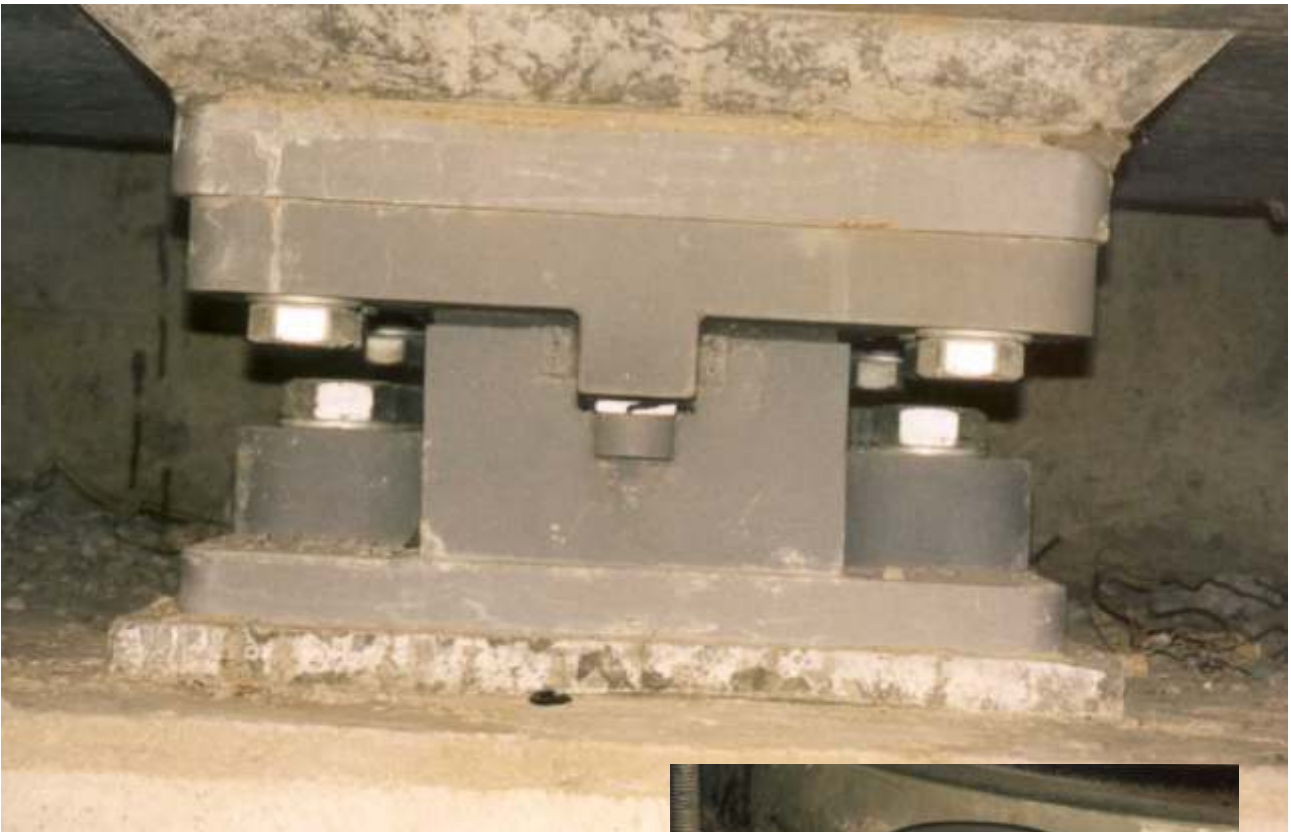
These pictures show an untreated section above and a protected section below, once more showing how difficult access was, especially to the rear of the bolted areas.

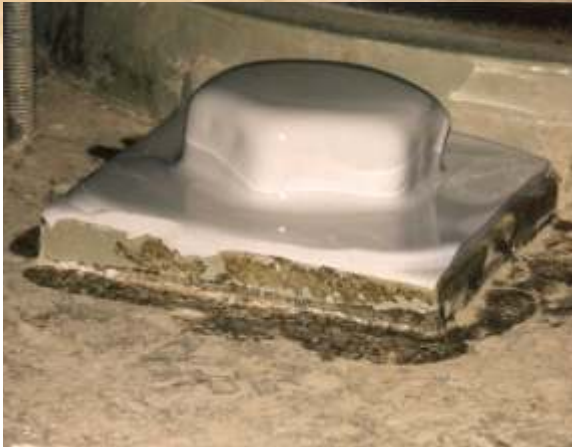
To the right is a close up view of the applied material. Protected within the Enviropel cocoon, the bolt head is bathed in inhibitors, preventing any further corrosion.

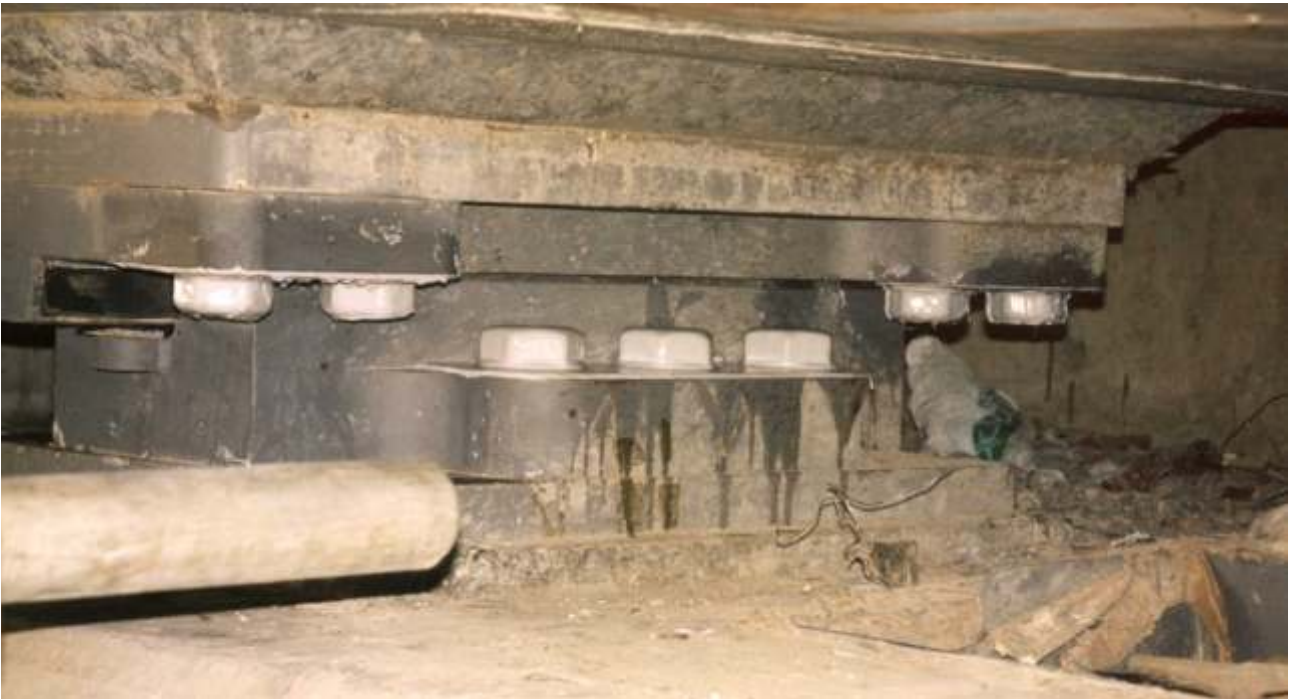
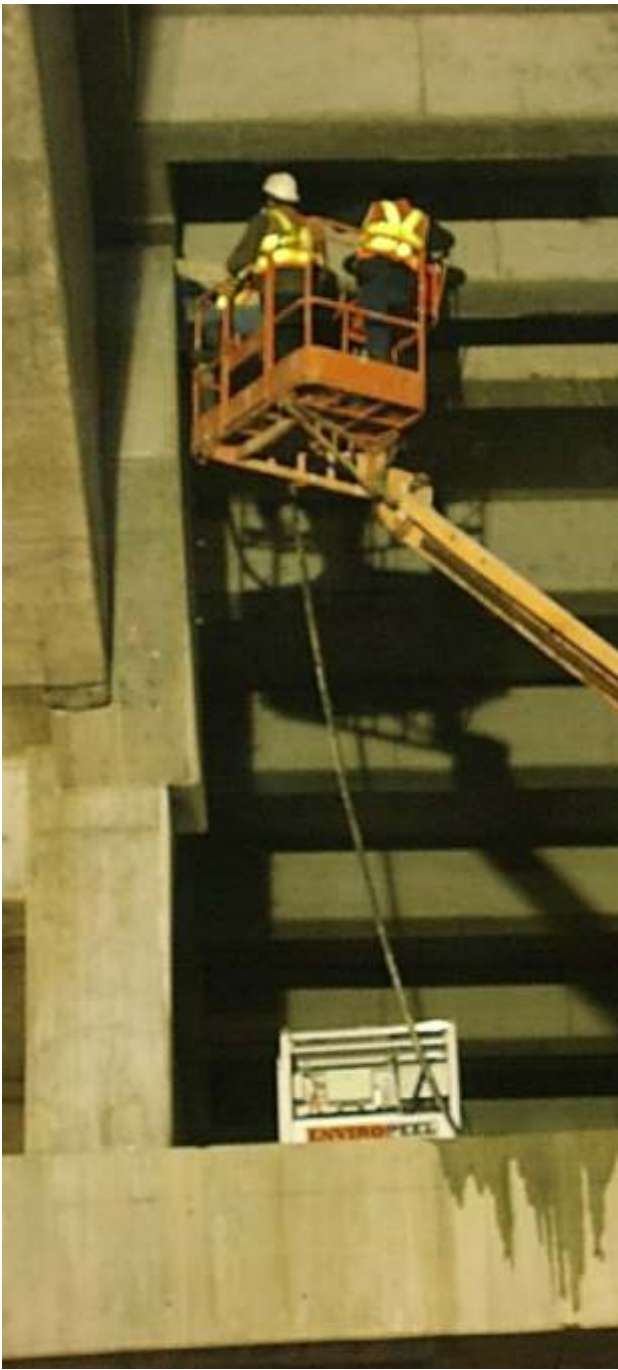
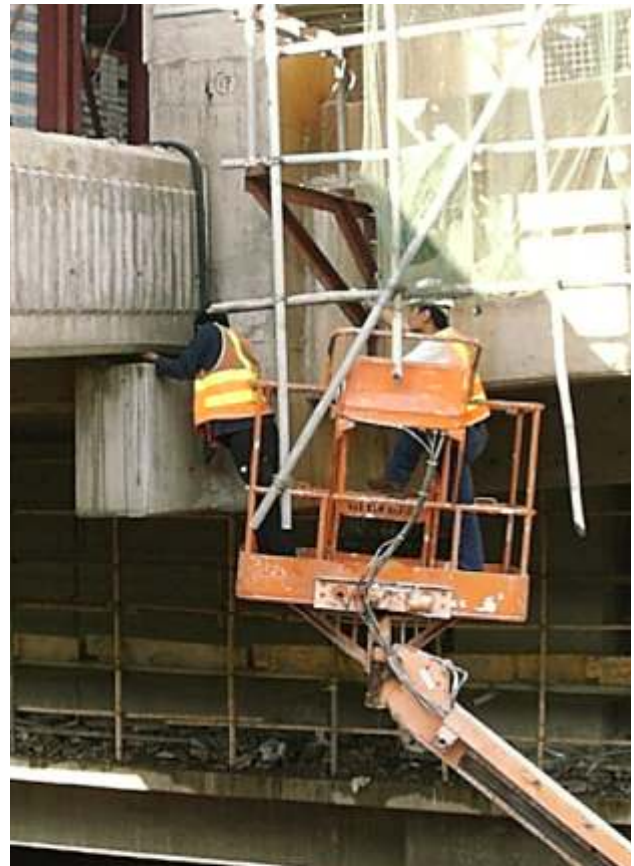
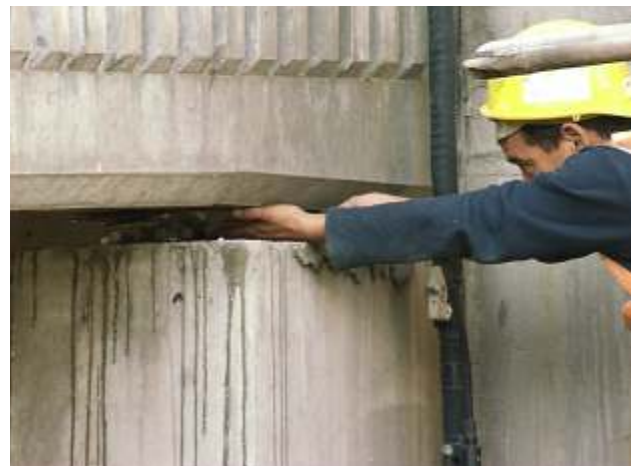
Despite the massive number of applications and machine movements, the Enviropeel system proved equal to the task. Although only using the standard hose, its 10 metre reach allowed applications to take place a considerable distance from the machine, as these pictures show.

Equally apparent from these photographs is how restricted some areas were and the site's logistical complexity. The key to the success of the project was the flexible approach allowed by the Enviropeel System, with techniques evolved to address issues that were specific to the project, avoiding delays and cost overruns.
